[Summary] Current Status of Shika Nuclear Power Station after the 2024 Noto Peninsula Earthquake (as of July 24)

Current Status of Shika Nuclear Power Station after the 2024 Noto Peninsula Earthquake (as of July 24)

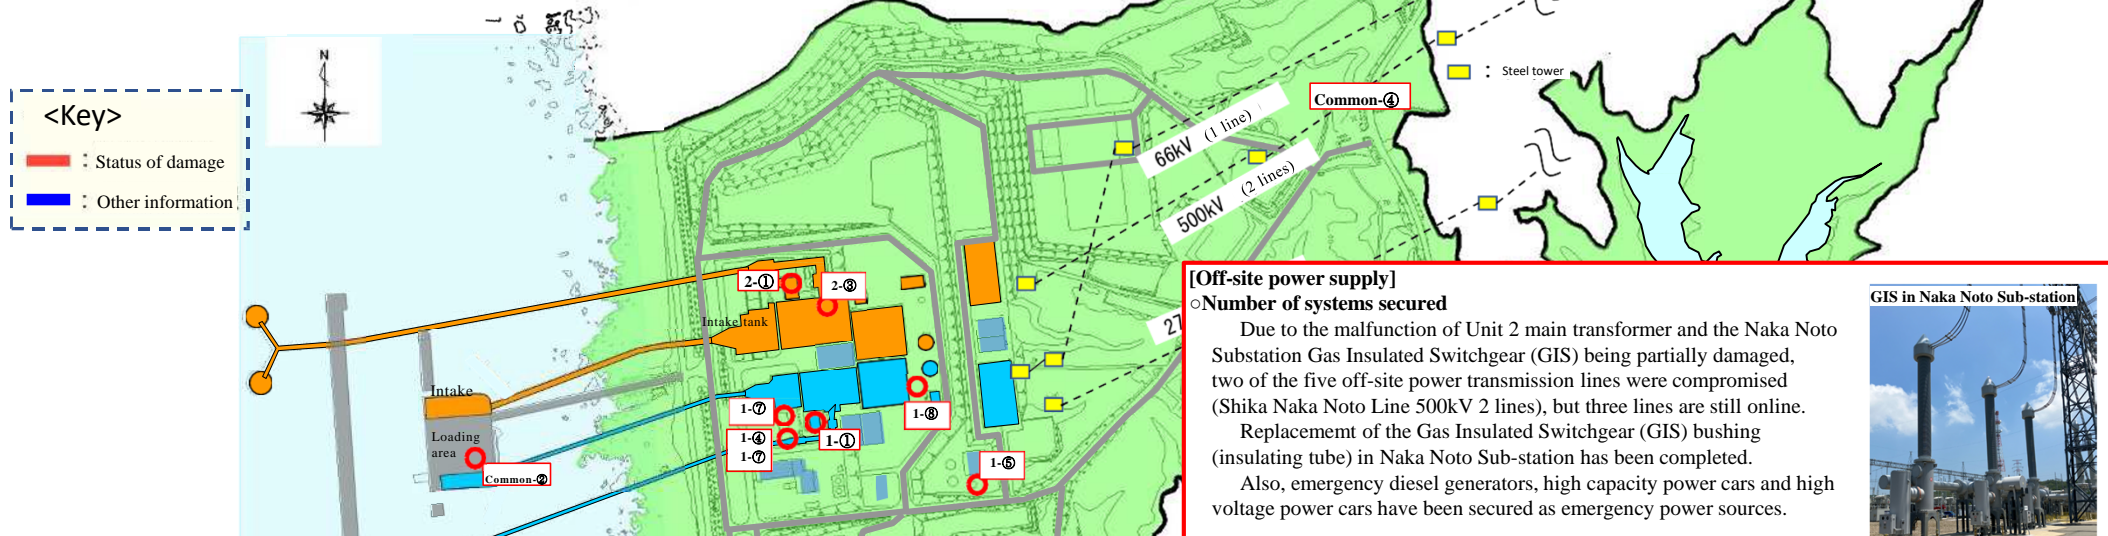
(2-③)

◦Turbine annunciator “expansion difference large” set-off

Annunciator “expansion difference large” was set-off at the shutdown Unit 2 low pressure turbine.

Confirmed contact marks between all of the moving blades and stationary blades of the high and low pressure turbine, and also confirmed damage to the generator rotation detector.

⇒ Annunciator was setoff while turbine was shutdown, and does not impact nuclear safety.

Turbine and generator to be inspected around the first half of FY2024, and repairs and restoration to be performed after checking for any damage.
